Best Practice for Wheel Torque and Clamping Force

Preventing loose and cracked wheels and wheel end components

W1.009 Rev.2 0320 ©2020 Accuride Corporation

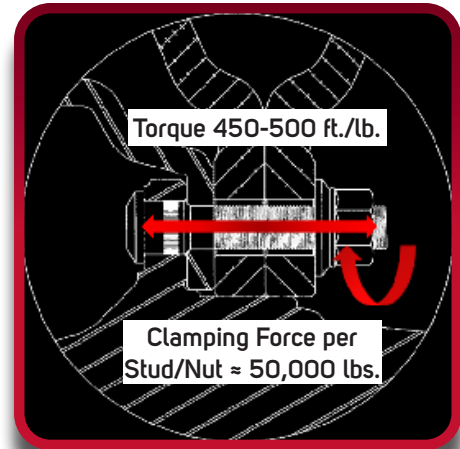
- If any one of the stud/nut combinations loses its clamping force, the load forces are redistributed over the remaining studs/nuts. This causes the adjacent nuts to fatigue.

- Insufficient clamping force may create "play" in the wheel. This can increase stress loads on the wheel and other components that lead to fatigue cracks, deformed stud holes, stud damage and, potentially, wheel loss.

- A common misconception in the industry is to correct low clamping force by over torque. This practice can stretch the stud beyond its yield point, rendering it ineffective.

- The ideal clamping force is achieved and maintained through the use of new fastening components that are applied using the manufacturer's specific torque and re-torque practice criteria (see chart on next page).

- The proper preventive maintenance practice is for drivers and mechanics to periodically inspect wheels and wheel end components. This makes it possible to identify and address issues at an early stage, before damage occurs.

- Inspecting a wheel's back-up diameter during tire and brake changes may reveal a scalloped back-up diameter. This indicates low clamping force within the wheel end. Ensure that all mounting surfaces, studs, and nuts are properly cleaned and oiled as described in the Safety and Service manual before the wheel is reinstalled.

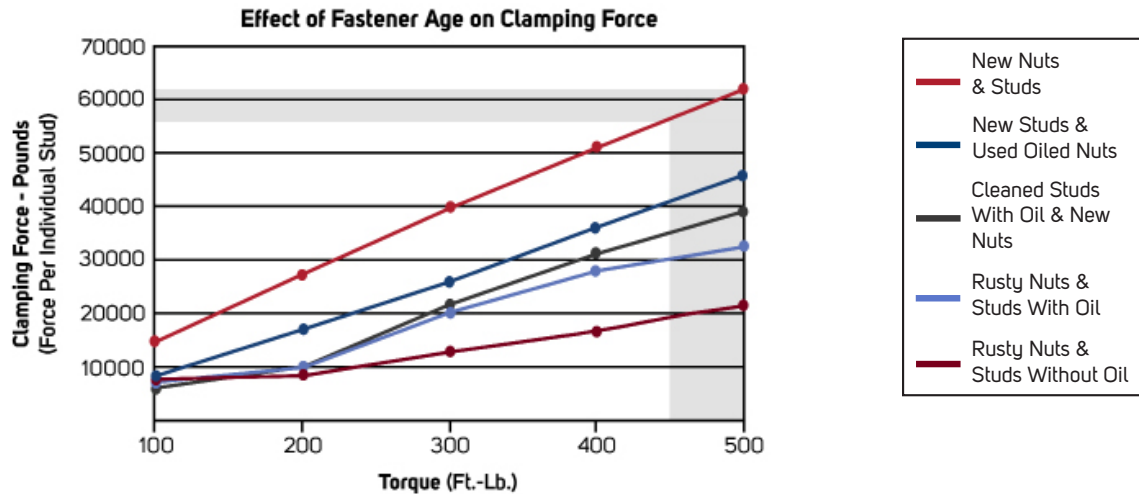
The condition of the studs and nuts has a direct impact on the level of torque that can be achieved.

(Study was done by using an M22 x 1.5 stud and two piece flange nut)

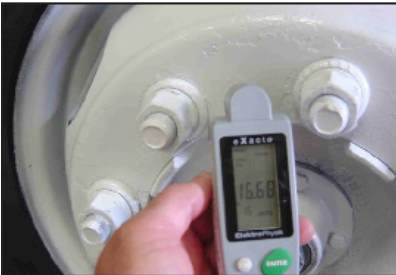
Paint thickness gauge reads 16.68 mils, above the maximum allowable thickness of 3.5 mils.

The maximum allowable paint thickness is .0035 inches (3.5 mils), which is about the thickness of a magazine page. If you cannot read the stamping, there is too much paint applied. **Such wheels should be repaired before being reinstalled on the vehicle.**

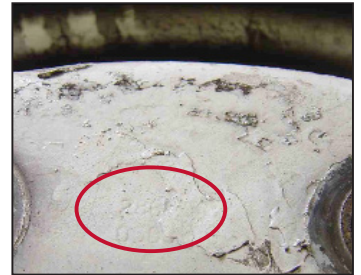
Visible signs that paint exceeds the maximum allowable thickness of 3.5 mils. Multiple coats, uneven surfaces, and illegible stampings indicate too much paint.
